AN INVESTIGATION INTO THE LOW CYCLE
COMPRESSIVE FATIGUE FAILURE MECHANISM
OF A COMPOSITE MATERIAL

SUBMITTED IN PARTIAL FULFILLMENT
OF THE REQUIREMENTS FOR THE DEGREE OF
NAVAL ENGINEER
AND THE DEGREE OF
MASTER OF SCIENCE IN OCEAN ENGINEERING
AT THE
MASSACHUSETTS INSTITUTE OF TECHNOLOGY

June 1970

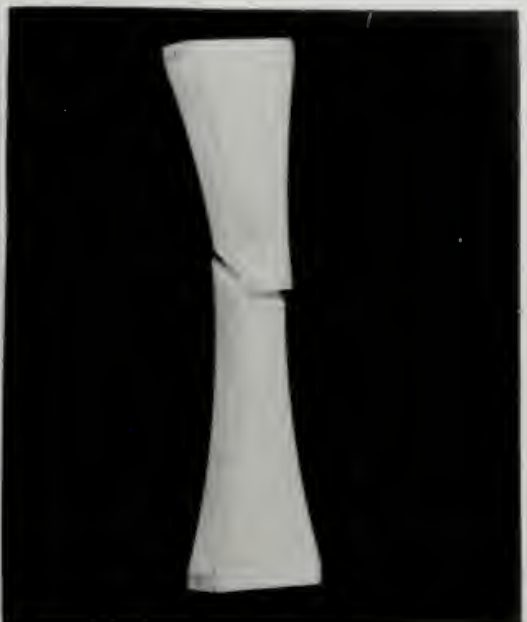
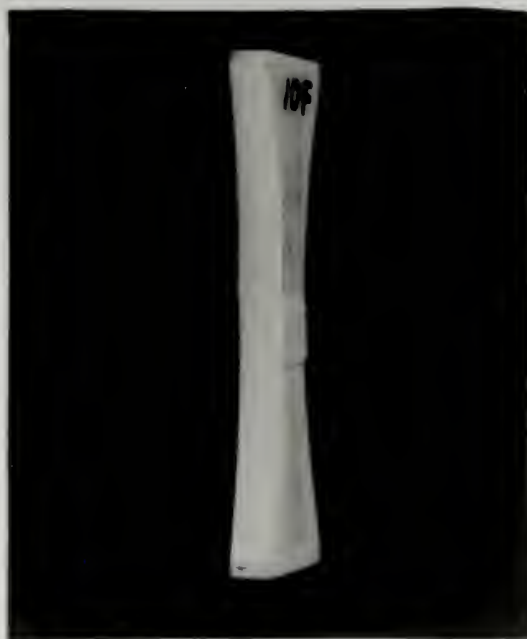
Typical Failures

On a macroscopic level, failures under compressive or compressive fatigue loading were generally indicative of a shear mode of failure when the specimens were restrained from buckling by using the support jig shown in Figure 2. The shear line generally occurred near, but not precisely centered about, the section of minimum area. Three basic variations in shear failure were observed:

(1) A slant fracture type of shear rupture along a single fracture plane inclined approximately 45 degrees to the load axis.

(2) A double slant fracture, or "single V", with either side of the V inclined at approximately 45 - 60 degrees to the load axis, and extending throughout the thickness of the specimen.

(3) A multiple slant fracture, or "double V", in which a second V is added to the single V fracture, usually extending through only part of the thickness.

Typical examples of the above variations in shear failure can be seen in Figure 3. A fourth type of failure, not shown, occurred when the support jig was not used. In this case, failure occurred by delamination and buckling of individual plies, usually starting at the outer surface plies and progressing inward toward the center of the specimen.

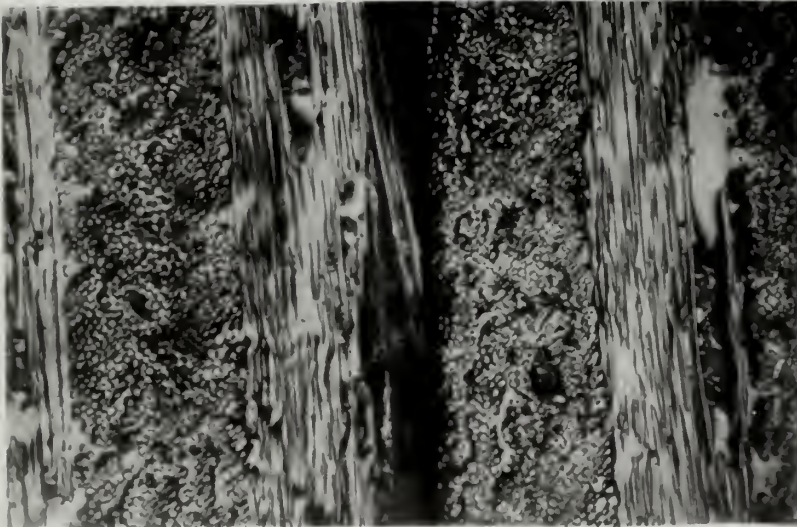
Figure 11
#10U
69,400 psi
30 Cycles
No Failure
120X
Parallel Face
Load Direction
is Vertical

Figure 12
#10N
91,000 psi
13 Cycles
Failure
120X
Perpendicular Face
Load Direction is
Out of the Page

The predominant effect observed in the microscopic examination of fatigue damage was the damage within the plies oriented parallel to the load axis (axial plies). This damage is characterized by axial separation of fibers, fracture of groups of adjacent fibers, and complete absence of fiber and matrix in elongated areas several hundred fiber diameters in length. Although many specimens exhibited an interlaminar separation damage as well, damage within the axial plies was the most frequently observed type of damage. Figures 6, 7, 11, 18(b) and 19(b) show typical examples of this type of axial damage, while interlaminar separation is observed in Figures 9, 12 and 19(a).

The observed cases of delamination, similar to that shown in Figures 9 and 12, could be explained by the tendency of elongated voids to appear in this interlaminar area. This hypothesis is supported by the findings of Fried (2), who concluded that such voids decrease the total bonded area and may act as loci for initiating the debonding, hence they constitute the primary factor in determining compressive strength.

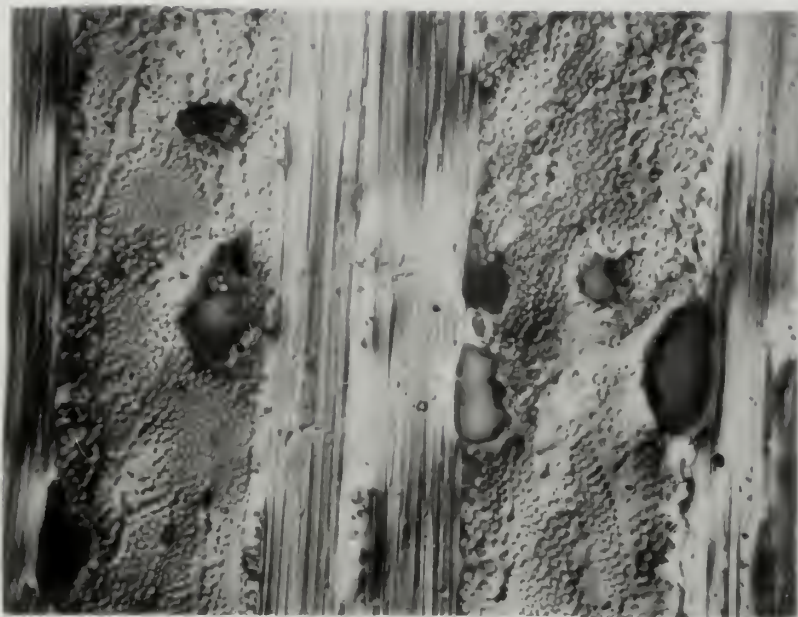
Figure 13
Laminate #6
Reference
120X
Parallel Face

Before proceeding to the development of a failure mechanism, a few general observations should be made with respect to the photomicrographs. First, it should be recognized that the use of the Nomarski interferometer, while providing increased contrast and detail, emphasizes the minute variations in the level of the polished surfaces. The existence of specimen damage is indicated by the non-uniform, elongated dark areas in the photomicrographs. It is considered that the damaged fibers and matrix in these areas were removed during the polishing process, leaving a void-like space. Actual voids, resulting from the fabrication process, while varying considerably in size from one laminate to another, are generally characterized by somewhat irregular but rounded boundaries. This can be observed in the relatively small interstitial and matrix voids appearing in Laminate 11 (Figure 5) and the large general voids of Laminate 6 (Figure 13).

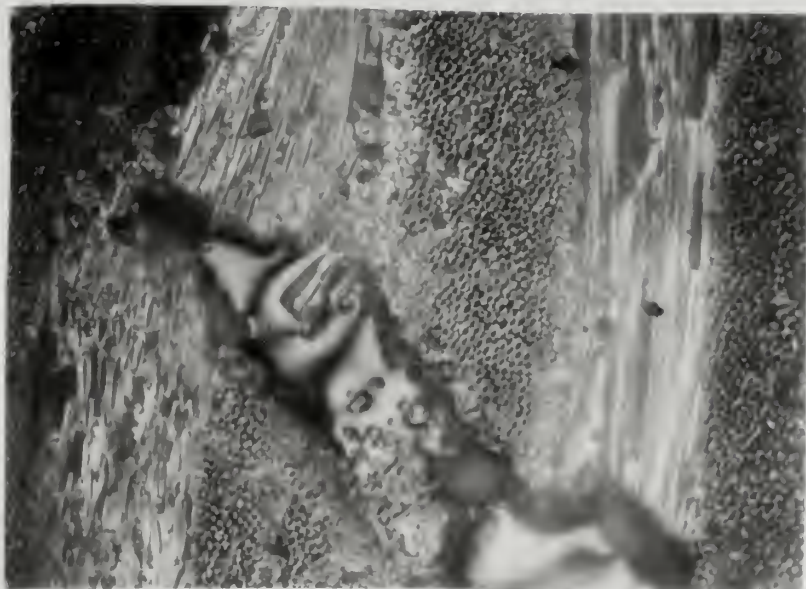
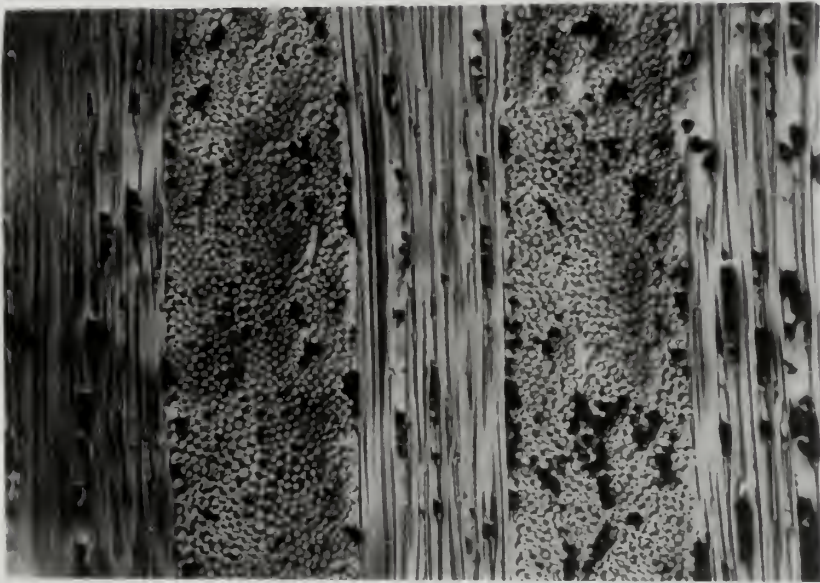
Figure 17. Specimen Number 11V (SW), Parallel Face, 120X. Reference Specimen, No Load Applied. Shown After Sea Water Immersion.

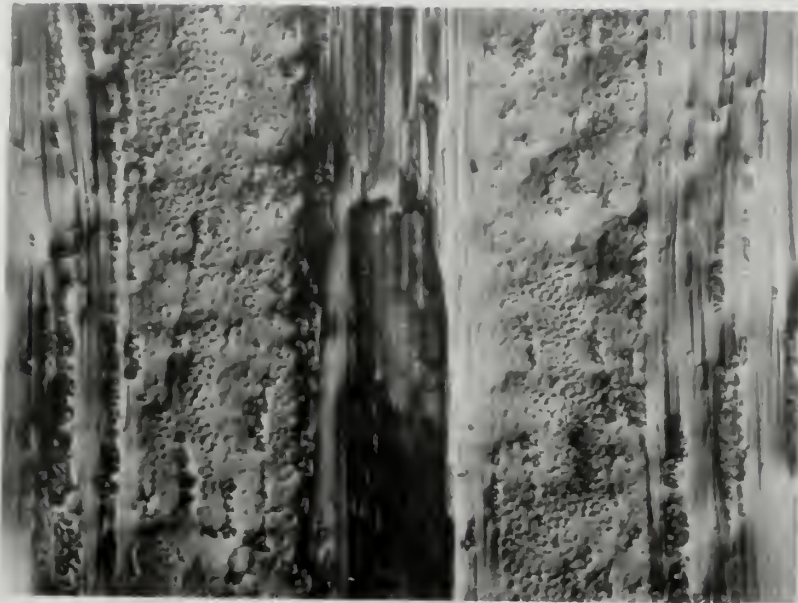
(a) Perpendicular face, showing damage in layer with fibers perpendicular to axis of load. Load applied perpendicular to plane of paper.

(b) Parallel face, showing damage in layer with fibers parallel to axis of load. Load applied in vertical direction.

Figure 18. Specimen 11H (SW), 120X, Fatigue Tested for 8 Cycles at 70,000 psi after Sea Water Immersion. Cycling Stopped Before Failure.

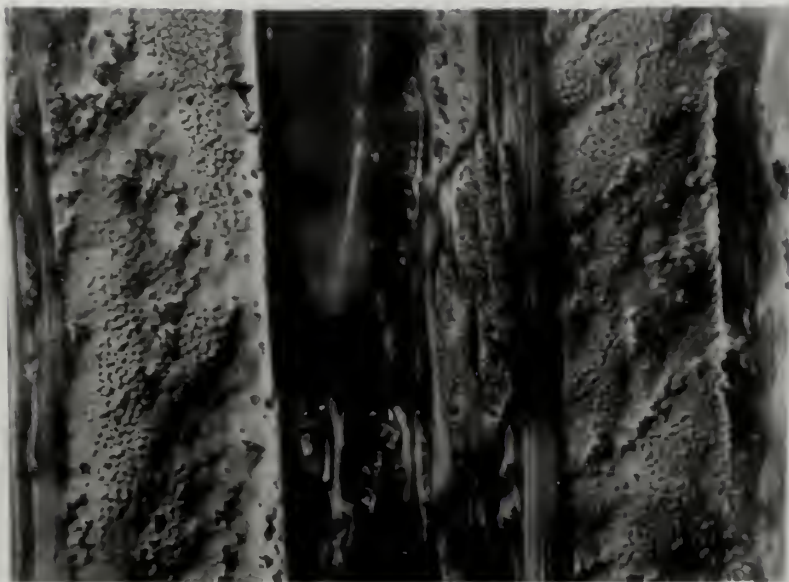
(a) Perpendicular face, showing interlaminar separation. Load applied perpendicular to plane of paper.

(b) Parallel face, showing damage in layer with fibers perpendicular to axis of load. Load applied in vertical direction.

Figure 19. Specimen 11P (SW), 120X, Fatigue Tested to Failure After Sea Water Immersion. Failure After 10 Cycles at 66,500 psi.
